## Conserving the Past Enriching the Future

### THE PLAZA, STOCKPORT ARCHITECTURAL PAINT RESEARCH TO THE FAÇADE AND FRONT OF HOUSE CLIENT: STOCKPORT PLAZA TRUST

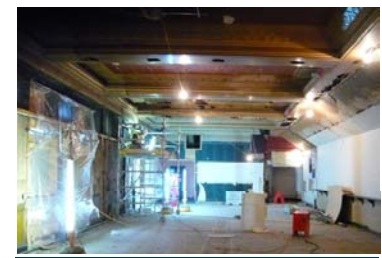
Plaza Cafe during renovation, 2009.

Hirst Conservation was engaged to undertake a campaign of paint research to the façade, the Plaza Café and front of house to provide key information for its intended restoration, the aim of

Our research was based on archive and documentary evidence, taken in conjunction with analysis of paint films and uncovering of historic paint layers on site. The research enabled the identification of many original colours and finishes. This valuable information taken in the context of similar interiors of the same dates, enabled complete decorative schemes to be re-introduced to the theatre.

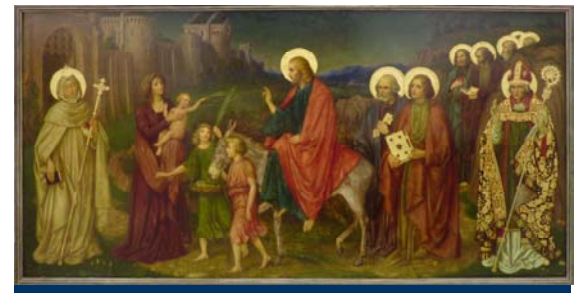
'Palm Sunday' after treatment.

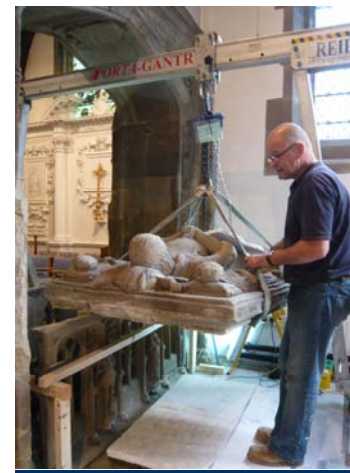
Dismantling the tomb chest.

Following an environmental assessment of the object and the building envelope, it was clear that interventive remedial measures were required to prevent the severe, ongoing deterioration, which included surface delamination

and disaggregation, with soluble salt activity affecting both the stone and the polychromy.

Further treatment included cleaning the monument, using dry and aqueous methods, and consolidation of the stone and polychromy. Thick salt crusts were removed mechanically, and fills and capping repairs were undertaken in areas of de-lamination and minor fracturing using non-hydraulic lime mortar. Broken elements were pinned and the fractures filled with lime mortar. Failing and inappropriate mortars were mechanically removed and replaced with non-hydraulic lime mortar. The conserved monument was then rebuilt.

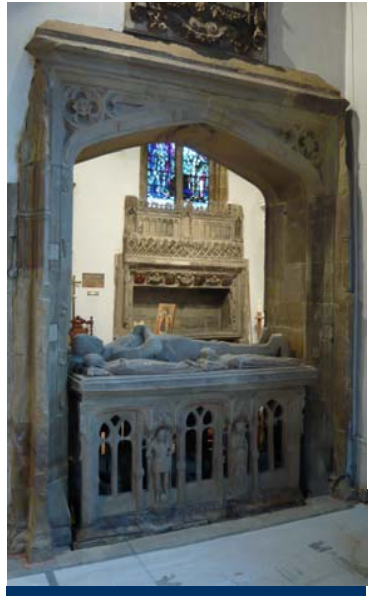
Tomb chest after treatment.

Additional treatment included the cleaning and retouching of the inscription plaque above the monument.

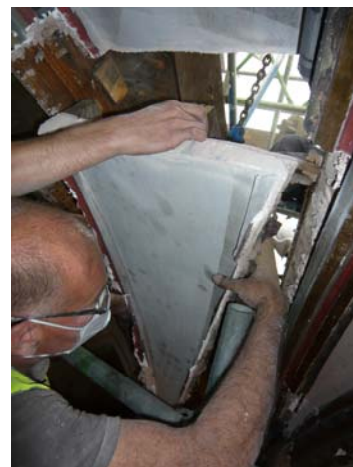
Our preliminary investigations involved a full condition survey, limited architectural paint research and cleaning trials to understand the environment and inform treatment proposals. In general, the condition of the ceiling was poor, with extensive rotten timber supports, plaster fractures and losses to the paint and gilding.

Panel being carefully removed.

The first phase of the project involved consolidating blistered and flaking paint layers prior to emergency construction works to the deteriorated timber supports. Some of the panels, which were supported by timbers infested with wet and/or dry rot, had to be removed to enable repairs to the ceiling

frame to be carried out. After cleaning and stabilisation back at our workshops, these panels were re-fixed to the new timbers.

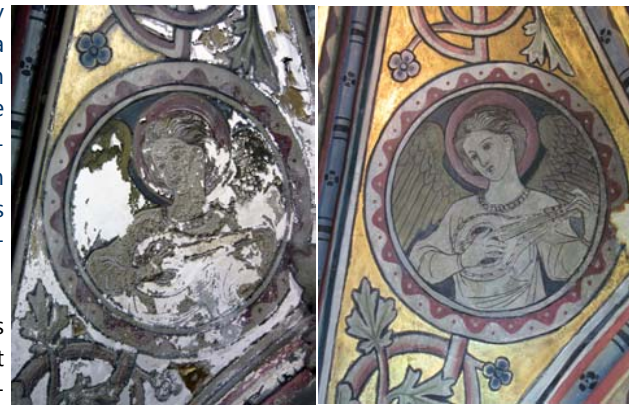
Ceiling panel with roundel before (left) and after (right) treatment.

The second phase of works involved further conservation and restoration works, including consolidation and stabilisation of delaminating paint layers, removal of surface dirt, filling of cracks and minor losses, and retouching of fills and areas of paint loss.

Where ribs and areas of plaster panels had been replaced due to rot, the stencilled, painted and gilded decoration was recreated.

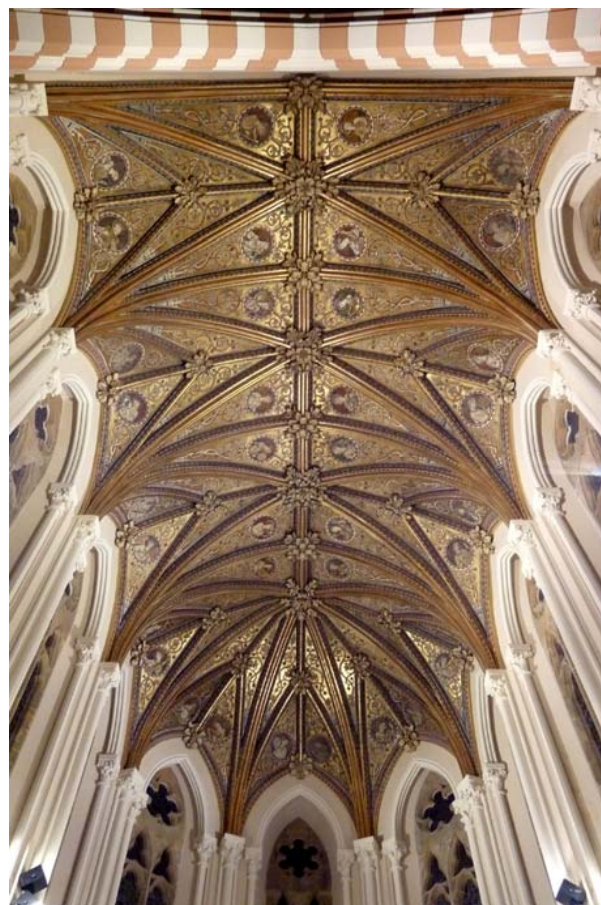
Chancel ceiling after conservation and restoration.

EW Pugin's rejuvenated ceiling can once again be fully appreciated and enjoyed by worshippers and visitors to All Saints Church.

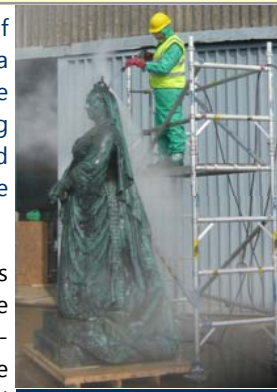
Cleaning the bronze statue.

Conservation treatment of the monument included cleaning the bronze statue using a variable pressure system and micro-abrasive where necessary, followed by re-patination and waxing. The granite plinth was also cleaned with the variable pressure system.

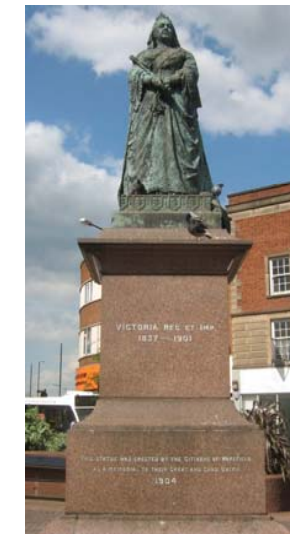
Before treatment.

The statue itself was generally in good condition but was covered in an uneven green/grey corrosion and dirt layer, or patina, caused by moisture and pollutants present in the outdoor environment.

The monument was dismantled with the use of a flatbed vehicle with a crane mechanism, and the component parts transported to Hirst Conservation's workshops for treatment.

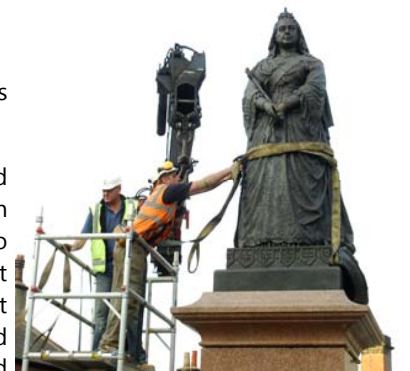
Positioning the statue on the re-built plinth after treatment.

The treated statue was then lowered onto the re-built plinth, where it can be enjoyed by visitors and residents of Wakefield.

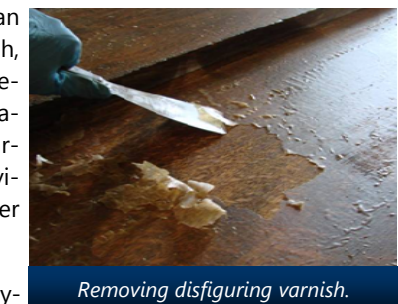
Removing disfiguring varnish.

The treatment proposals followed two initial site visits, cleaning and dismantling trials and a condition survey. Treatment of the timber elements involved cleaning and the careful removal of a failed, disfiguring intumescent varnish. Losses to the lettering were filled, sized and regilded using 23 $\frac{3}{4}$  carat gold leaf.

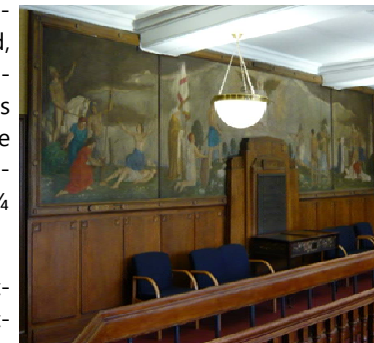
Monument before (left) and after (right) treatment.

Conservation treatments of the paintings ranged from varnish removal,

application of an isolating varnish, filling and re-touching, application of a final varnish and the provision of a strainer bar lining.

The lining of polyester sail cloth effectively flattened the sharp angle of the crossbars, providing improved tension and a good seal (acting as an effective dust barrier).

Once the monument had been reassembled, a final protective coating was applied to the wooden elements.
