HIRST CONSERVATION EASEL PAINTINGS STUDIO

Since opening in 2007, Hirst Conservation's easel painting's studio in Laughton, Lincolnshire has enjoyed a variety of commissions from both public and private collections.

Recent treatment of two paintings is described below.

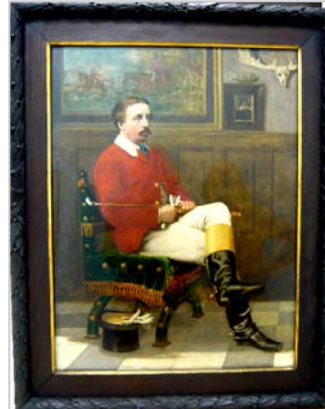
Portrait after treatment

On arrival at Hirst's studio, this portrait of R.H. Ainsworth, dated 1875 and signed with the initials 'W.K.K.' was found to be in sound condition, marred only by dirt, a discoloured varnish, and drying cracks in passages of the paint film.

Following an isolating varnish of Paraloid B72, re-touching was undertaken using a synthetic resin and dry pigments, and a final varnish of semi-shiny MS2A applied.

Finally, the painting was framed, which included the insertion of non-reflective, UV filtering Tru-vue™ Museum Glass and a backing board to protect the object from environmental deteriogens and impacts.

Tests to establish the safest and most effective treatment methods found that the surface dirt could be removed using ammonium hydroxide (pH 8), with localized areas of more intractable dirt (e.g. on the floor tiles) removed with tri-ammonium citrate (5%).

Varying sensitivities of the light and dark paint layers meant that the varnish could be fully removed from some areas but only selectively removed from others, in both cases using the solvent propanol and cotton swabs.

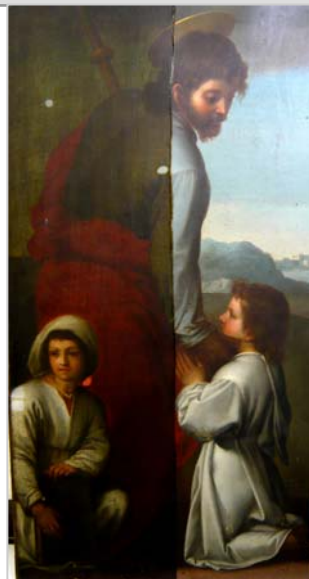
It is difficult to appreciate just how severely a degraded and yellowed varnish can compromise the appearance of an image until one encounters an oil painting like that from St. Albans Church (right).

The aged varnish, composed of a natural resin such as dammar or mastic, would originally have been applied as a clear liquid to saturate and protect the paint layer. Over several decades the varnish had hardened and darkened due to molecular cross-linking and photo-oxidation, making the painted image almost impossible to see behind a murky veil of yellow.

Yellowed varnish removed from the left side of the painting.

Removal of this varnish revealed the beautiful and vibrant colours of the painting, as seen on the right hand side of the image above.

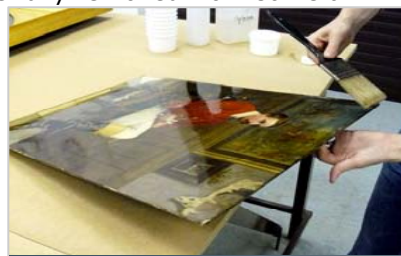
Application of an isolating varnish

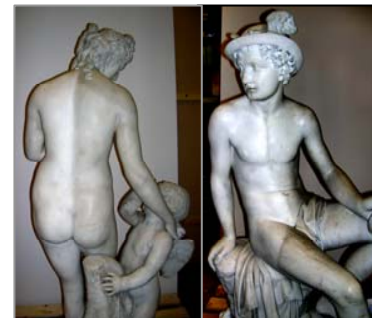
Statues of **Venus Chiding Cupid** and **Mercury**, Joseph Nollekens (1737-1823), with dirt removed from their left sides.

surface dirt that had accumulated on their backs and in their finely carved detail.

Following a series of cleaning tests and UV examination for waxy/oily coatings, soft brushes were employed to dislodge loose dirt, followed by cotton swabs of xylene to remove the

grease. More intractable areas of dirt were then cleaned from the marble using V&A solution cleared with white spirits.

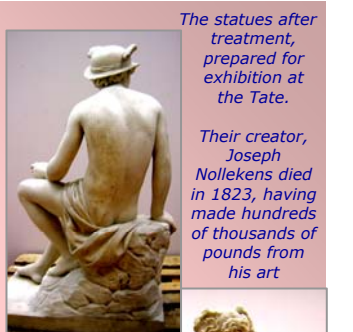
The statues after treatment, prepared for exhibition at the Tate.

No protective coatings were applied after cleaning as, following their exhibition at the Tate and return to the Usher Art Gallery, these beautiful statues will be displayed for all to enjoy in a stable museum environment.

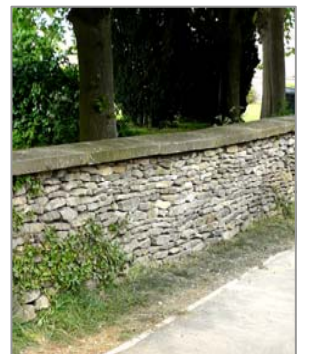
An unwelcome encounter with an out-of-control car led to the partial demolition of a traditional dry stone wall bordering St. Andrew's Church, Cranwell. Hirst Conservation was invited to reconstruct the wall and re-bed the coping stones.

The reconstructed dry stone wall retaining its original materials

employed in different regions of the country. In this Lincolnshire example, the two outer elevations were built up with the existing facing stone, whilst the inner cavity was firmly packed to secure the facing stones.

Rebuilding the wall demonstrated a crucial principle of conservation, that is, the use of original material to reconstruct a failing structure, without incorporating additional materials that could affect its integrity.

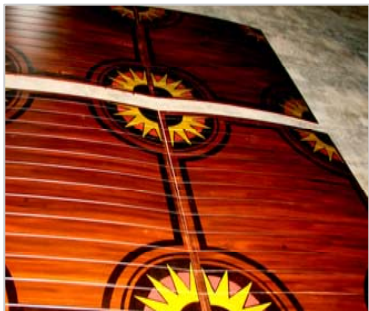
The new stencilled panels created to cover the plastered 'balcony' section of the ceiling.

design were retouched using acrylic paints. Tests showed that removal of the plaster from the original panels in balcony section of the ceiling could not be achieved without dam-

aging the polychrome, so new panels were fitted over the plaster and stencilled to replicate the 1870s design. A final varnish of MS2A was applied. Conservation and reconstruction of the ceiling has resulted in this long neglected feature regaining its rightful place as the crowning glory of an exceptional public space.

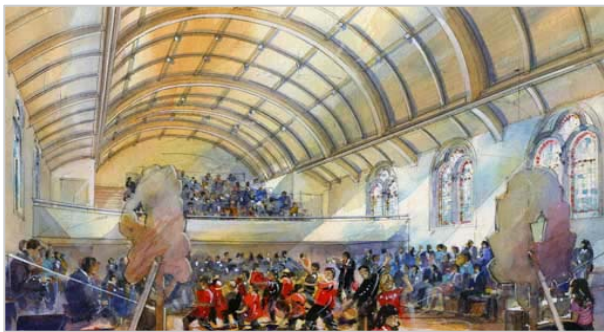
In 2007, Hirst Conservation was asked to inspect the condition of the original polychrome ceiling above the plaster panels, with a view to its cleaning, conservation, and ultimately its revealing as the true ceiling of the Assembly Room. Our conservators found a polychrome ceiling frozen in time, still coated with the thick carbon deposits and

Artist's impression of the Assembly Room with its original ceiling revealed and restored.

In 2008, Hirst undertook the cleaning and conservation of the whole ceiling. Tri-ammonium citrate, applied and cleared with sponges, was successful in removing the dense dirt from the polychromed wood. Beneath the dirt lay a simple but effective design of which the principal feature was a sun with a gilded central boss. Severely damaged or missing sections of the

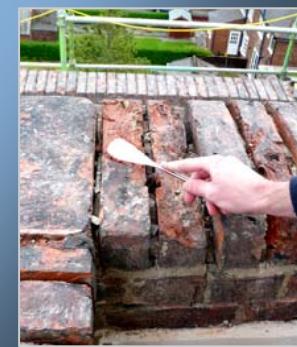
Removal of loose brick and cementitious pointing from the parapet coping stones

In 2007, Hirst Conservation was invited to evaluate the condition and stability of the visibly decaying bricks on the parapet and walls of St. Chad's Church in York.

The assessment included an on-site examination of the walls, analysis of the pointing mortar to establish the composition of original and repair mixes, and semi-quantitative soluble ion analysis in conjunction with micro-chemical testing to establish the salt species present. These procedures helped to determine the most likely causes of brick degradation, enabling the most appropriate remedial measures to be established.

The preferred option for treatment was to conserve and repair the bricks in situ, so that their deterioration was reduced, whilst the character of the building, with as much original material as

possible, was retained. Re-pointing, using a more porous mortar, would relieve the stresses of migrating and evaporating water (with associated salt precipitation) in the bricks by offering an easier transpiration path.

Final treatment included careful removal of the non-porous pointing and decayed bricks, application of a biocide, dirt removal using the Doff™ system, re-pointing using porous hydraulic lime mortar mixes, the insertion of new bricks in areas of loss, and final pointing and profiling using colour matched hydraulic mortars.

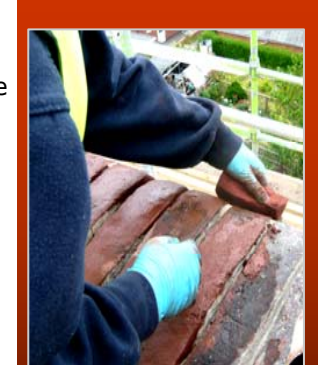
New brick insertions and re-pointing of the parapet using colour-matched hydraulic mortars

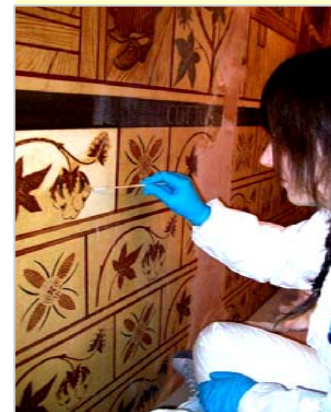
Removing yellowed varnish

Those areas that remain are often coated in a yellowed varnish.

Hirst Conservation was commissioned to clean and restore a damaged area of original decoration, which included a frieze of figurative panels representing 19th century industries in Lancashire. Coated in dirt and a resin varnish, a large

part of the polychrome was also missing where a pipe had been removed. Following dirt and varnish removal, this missing area was reconstructed using acrylic paints and glazes of Paraloid B72 with dry pigments, allowing this unique depiction of the county's proud industrial heritage to be enjoyed once again.

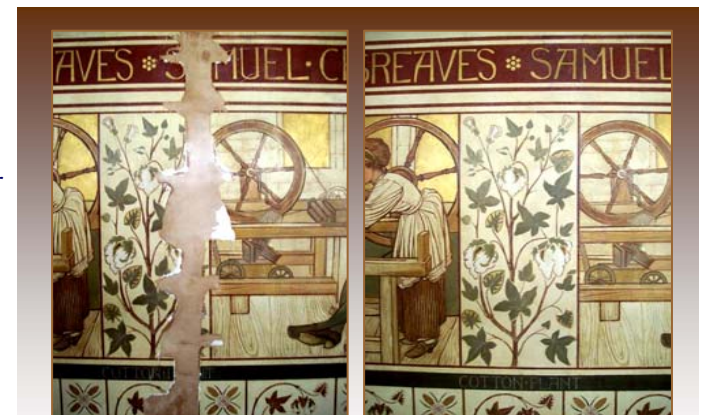
Figurative frieze on the upper wall after removal of dirt and discoloured varnish, showing (left) large area of missing decoration, (right) the same area after retouching.
